Inspector's Notes

January 2019

Asbestos?

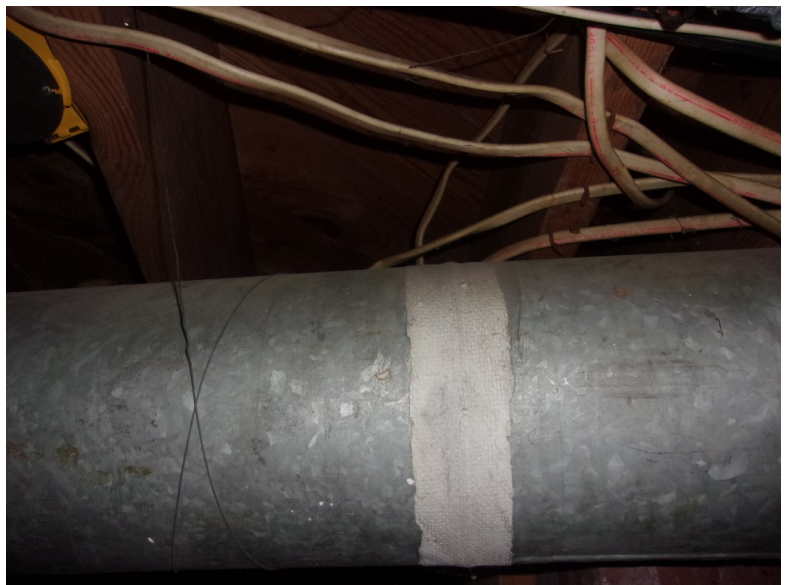
One of the more common findings is the Asbestos Tape used on HVAC ductwork in older homes. It comes in the form of a white tape wrapped around the joints of the ductwork. In this form the asbestos is relatively harmless as long as it's left alone.

It can be encapsulated (covered) to keep it from becoming free-floating. Spray paint is commonly used to coat the surface of the asbestos. Some people use duct tape, though eventually it will degrade and come off.

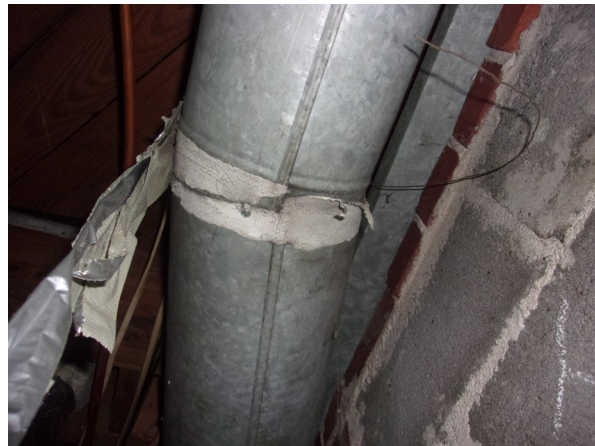
Asbestos becomes a problem when it's friable; free-floating. In the photo to the right you can see where grey duct tape was used to cover the asbestos tape, only to be pulled away exposing the asbestos tape which has become torn and jagged. These jagged edges present friable asbestos which can easily become airborne. At this point the asbestos should be handled by a qualified expert.

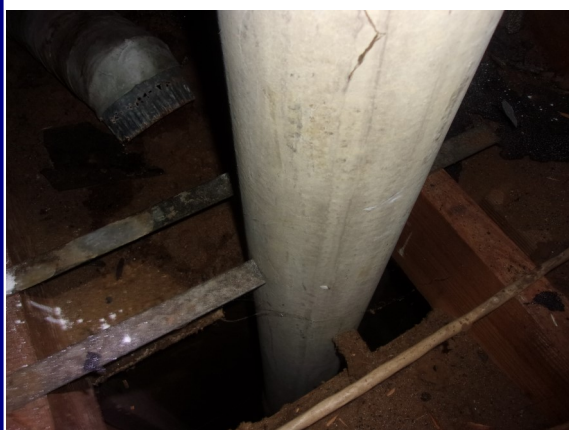
Another common area is **Transite** pipe which was used as exhaust ducts for HVAC furnaces. Transite is a cement compound that contains asbestos. In the photo to the left the pipe comes up from the furnace in the basement and exits through the attic. As with the tape, it can be painted over (encapsulated) and only becomes a problem when it becomes damaged and friable. Once friable you'll need an expert to remove it.
